LINAC 2026 | DAEJEON, SOUTH KOREA

# Post-Mortem Insights into the SNS RFQ01: Implications and Paths Forward for High Beam Power Operation

Haitao Ren

Spallation Neutron Source, ORNL

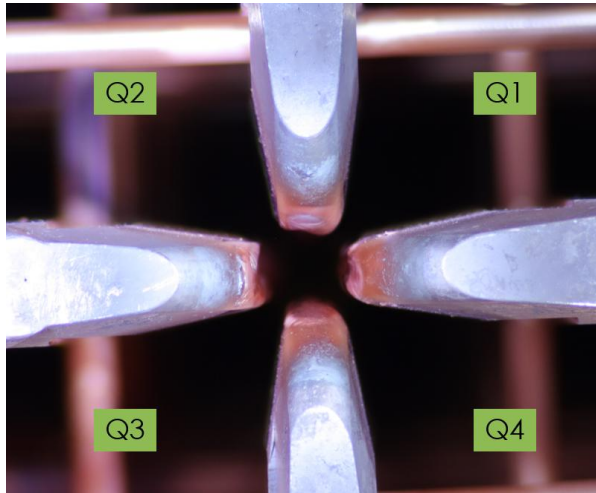
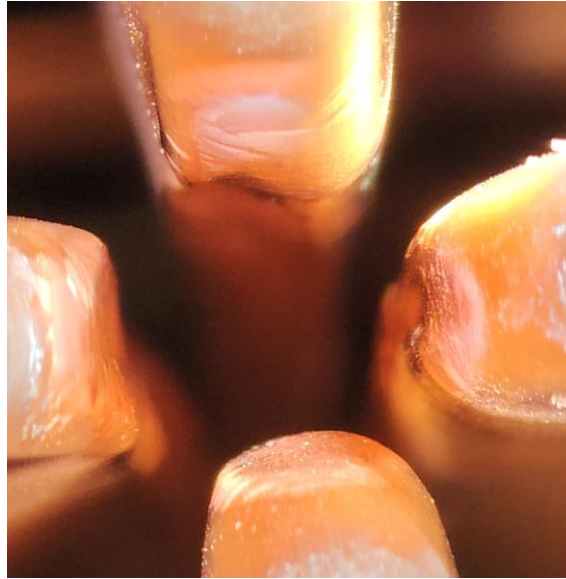
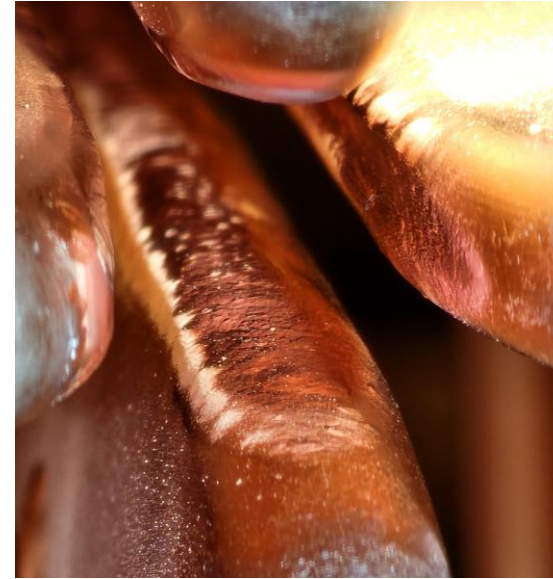
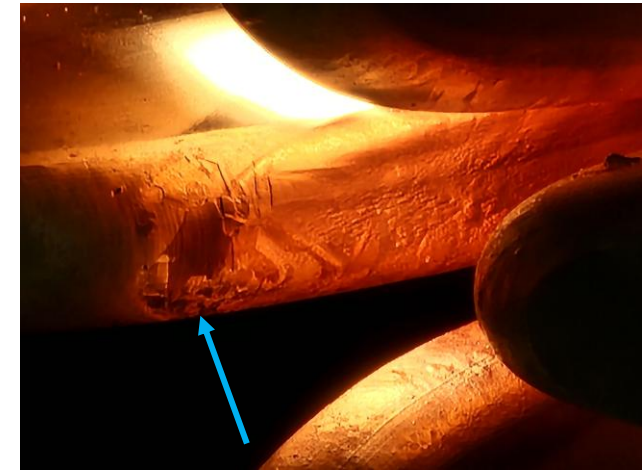
# Visual inspection – Substantial erosion at entrance

- Substantial erosion damage observed on the first a few inches of vane tips
- Copper sputtering (with 65 keV H<sup>-</sup> ions) is suspected a cause of the erosion
- Copper blistering can result in modification of physical properties of the copper surface and in the increased erosion rate

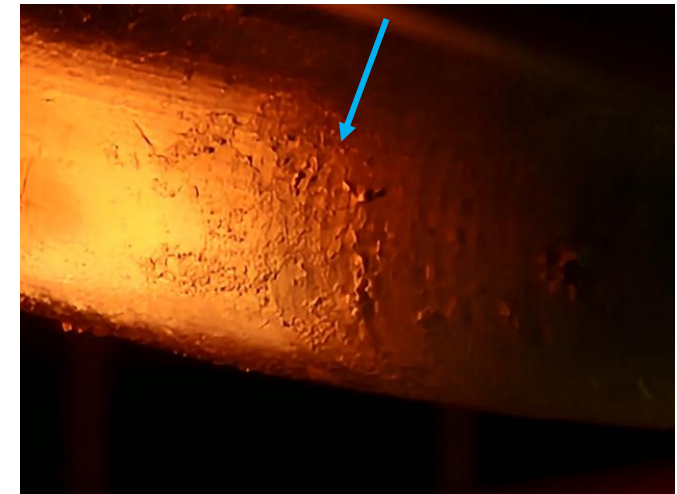
Suspected copper blistering

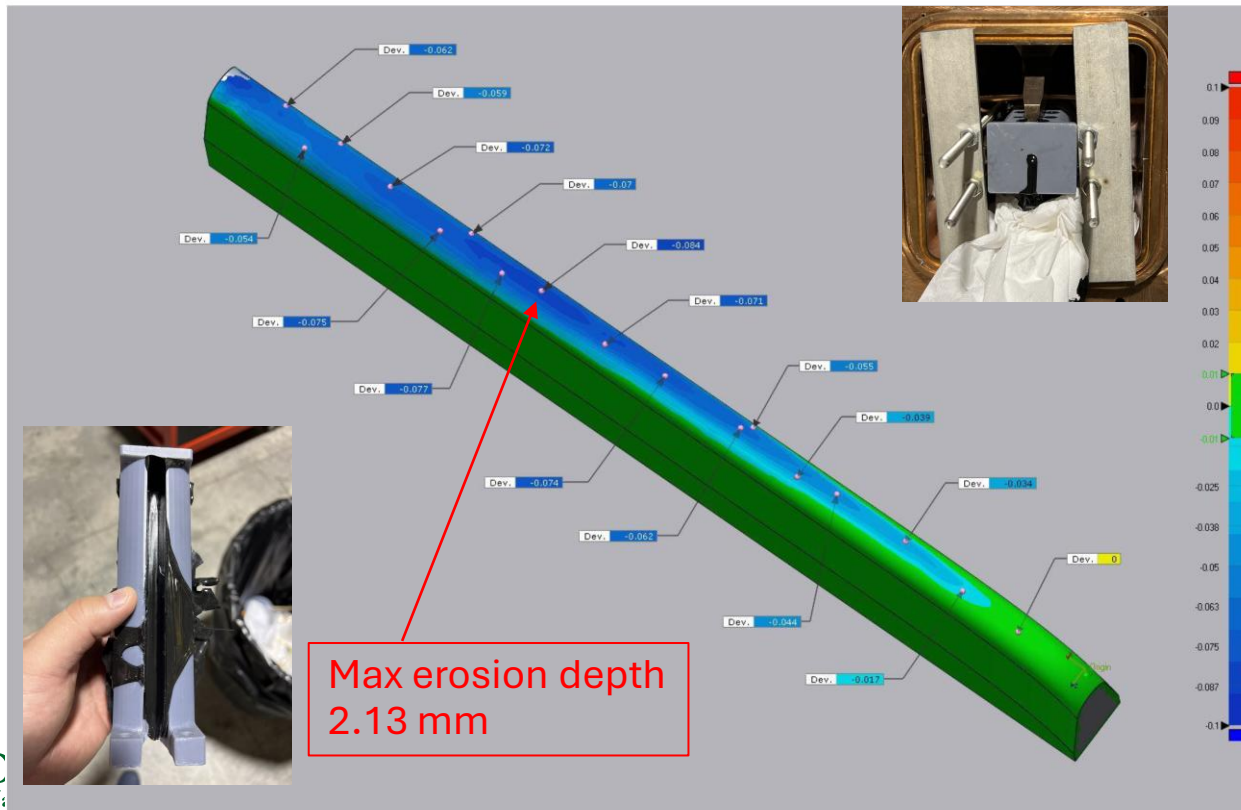
*RFQ 1 – Top Vane (View 1)*

- RepliSet is a specialized, fast-curing two-part silicone rubber replication system
  - Special mold designed to fit RFQ structure
- The cured replica was digitized on a precision tabletop laser scanner
- Only cover the first 6 inch of vane tips
- The scan shows a maximum erosion depth of 0.084 in (2.13 mm)

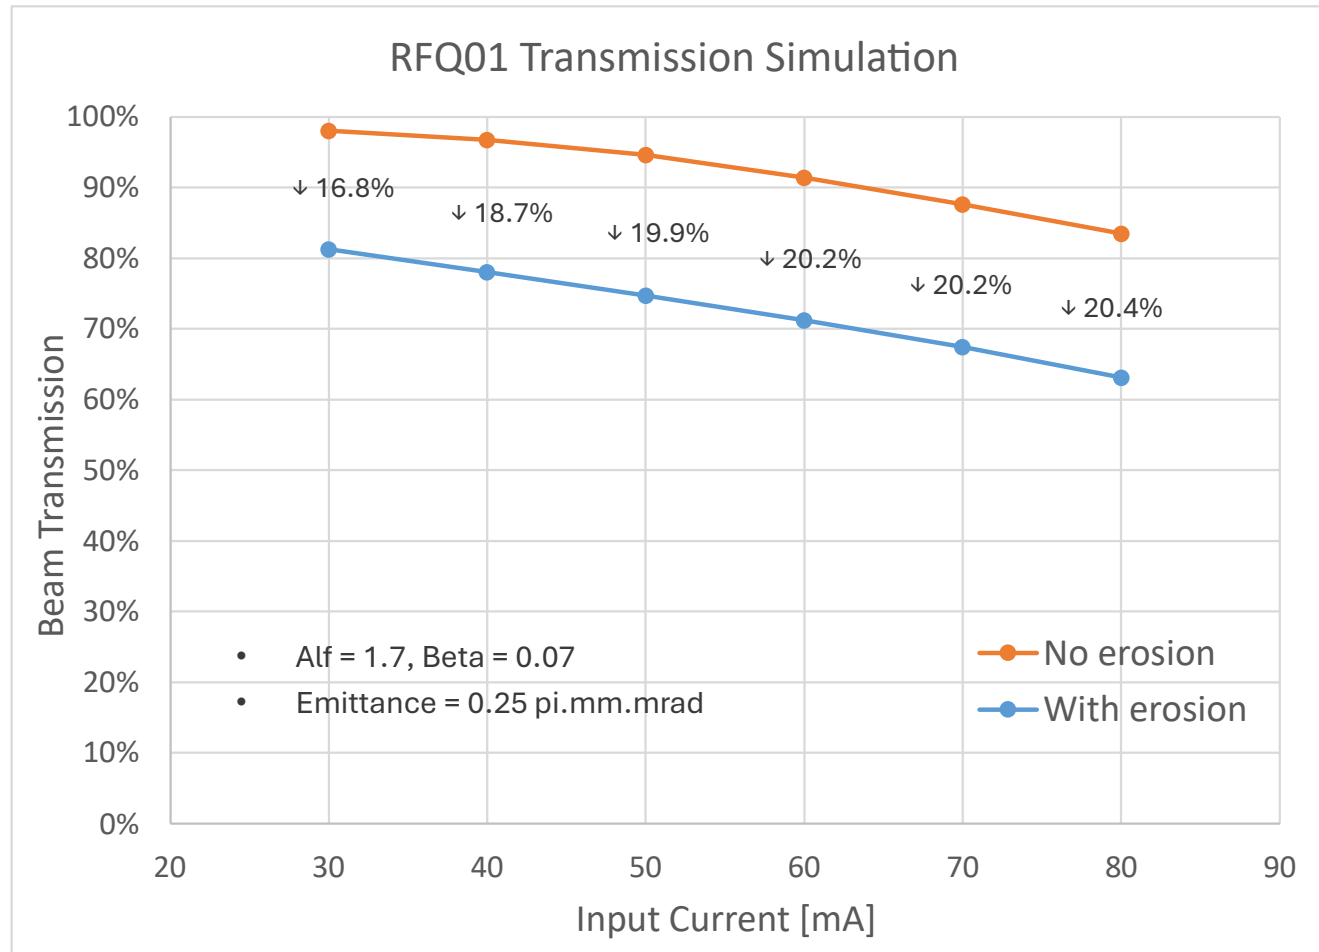
Considering the entrance erosion only, RFQ beam transmission drops by about 20%

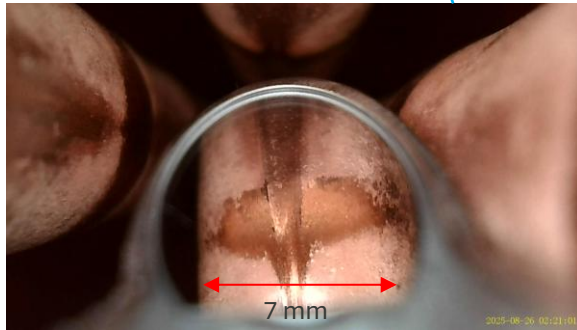
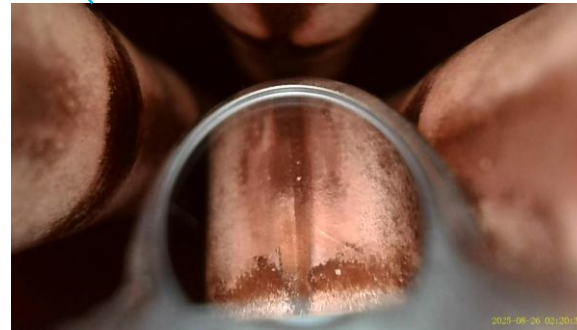
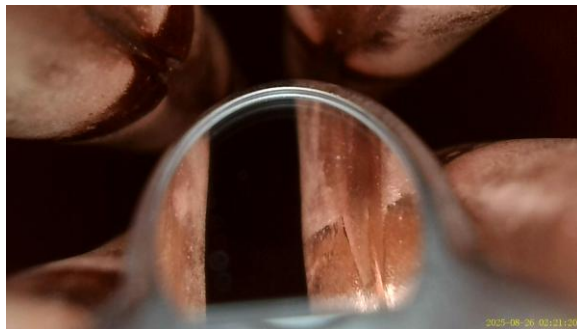
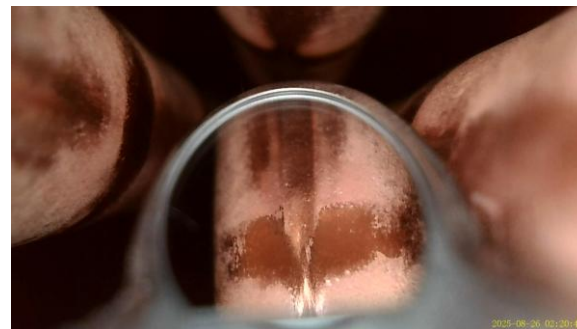
More erosion damage observed on vane tips in the second half of Module #1

- Entrance erosion correlates with the 65 keV input beam
- Localized erosion in downstream section of Module 1 needs better understanding
- Routine borescope inspection now applied to other SNS RFQs
- Mitigations at SNS:
  - Chopper upgraded to blank RFQ beam off-cycle – implemented
    - IS beam fully chopped now, won't enter RFQ
  - Under study:
    - Magnetic LEBT option
    - Additional collimation before RFQ
    - New RFQ design study for higher transmission
