CURRENT STATUS OF TPS VACUUM SYSTEM

Yi-Ch. Yang[†], Ch.-K. Chan, Ch.-Ch. Chang, Bo-Y. Chen, Ch.-Mu Cheng, T.-W. Hsu, J.-H. Kang,
National Synchrotron Radiation Research Center, Hsinchu, Taiwan

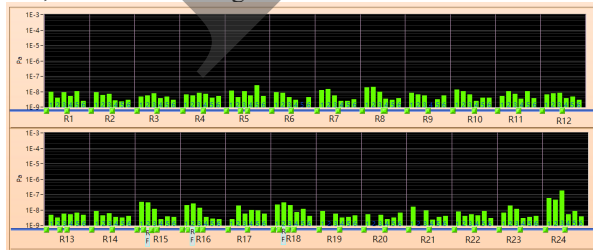
The vacuum pressure distribution of the storage ring under 500mA operation is illustrate in Fig. 1, which shows a higher pressure spike in the SR24 section resulting from the machine upgrade in 2026. The dynamic average pressure is 8.9 nPa, compared to a static pressure of 6.8 nPa without beam. To date, 17 insertion devices (IDs), two superconductivity cavities, and one harmonic cavity (HC) have been installed in the straight sections of the storage ring. Corresponding vacuum components, including bending magnet chambers and front-end (FE) vacuum system, have also been upgraded [1, 2]. The lumped NEG-ion combination pumps used in EPU ID vacuum chamber was developed to improve and increase the effective pumping speed [3]. A vacuum gauge was installed at the center of each EPU chamber to measure local pressure accurately. The average pressure rise normalized to the beam current dP/I (Pa / mA), follows a downward trend proportional to $D^{-0.791}$, was shown as Fig. 2.

Figure 1: The vacuum pressure distribution of the storage ring.

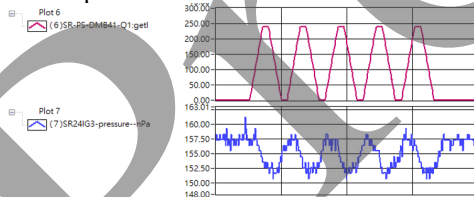
- Certain vacuum pressure readings are influenced by the operating current of nearby magnets. Fig. 3 illustrates an example where the SR24IG3 gauge reading fluctuated during the magnet degaussing process. Once degaussing was complete and the Q1 magnet was set to its nominal current of 165A, a slight drop in the gauge reading was observed. Despite the symmetric configuration of vacuum gauges and magnets throughout the TPS, such interference affects only a limited number of gauges. Attempts to shield the gauge heads with Mu-metal proved ineffective. We are currently investigating potential crosstalk between the vacuum gauge signal cables and the magnet power cables as a possible root cause.

Figure 3: SR24IG3 fluctuated during magnet degaussing.

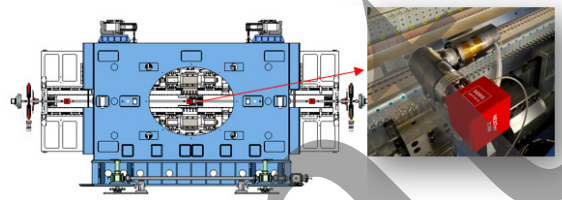
Fig. 4. After long term operation, this gauge began to fluctuate randomly, showing no correlation with the beam current. Although lead shielding was installed around the gauge head to prevent radiation damage when the EPU chamber was first commissioned, the effectiveness of this shielding appears to have degraded. This gauge functioned correctly initially but began to show signals of failure after approximately one year operation.

Figure 4: SR20IG2 is located at the center of the EPU chamber.

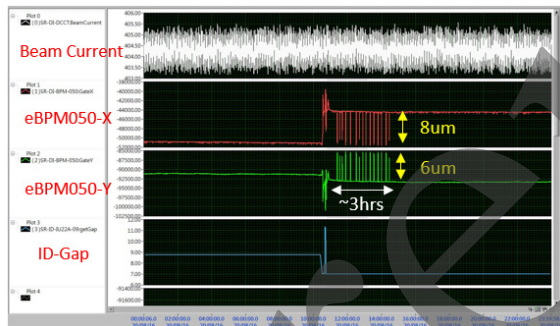
Abnormal eBPM signals have been observed in both straight and arc sections. Most of these anomalies occur intermittently or randomly. If a signal exhibits excessive instability, it is excluded from the orbit feedback system. Using eBPM050 as an example, its abnormal behavior has been found to be highly correlated with the switching of the upstream ID. Interestingly, these anomalies are not caused by the same electrode (button) every time. Furthermore, the duration of these events varies significantly; some are transient, while others persist until the next ID operation, sometimes lasting over 12 hours. As shown in Fig. 6, an ID gap adjustment resulted in position fluctuations of approximately 8 μm along the X-axis and 6 μm along the Y-axis, lasting for about three hours. Despite the Instrumentation and Control (I&C) team replacing cables, electronics, and even the electrodes, the issue persists, and the exact root cause remains unclear.

Figure 6: Abnormal signal of eBPM050 is correlated with the switching of the upstream ID.

To investigate this issue, a vacuum test section will be installed downstream of the SR05 section. An additional eBPM will be positioned as close as possible to BPM050 to determine whether the anomalies occur simultaneously across both units, which will help clarify the source of the interference.
