ANALYSIS AND REFURBISHMENT OF A RADIATION-DAMAGED UNDULATOR*

Shanghai Advanced Research Institute, Chinese Academy of Sciences, Shanghai, China

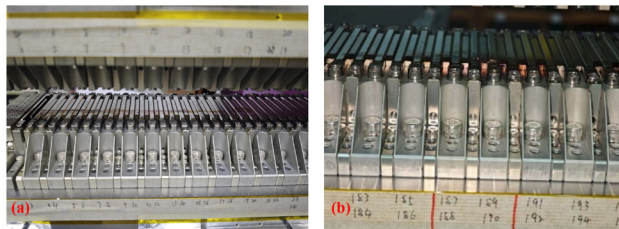
Figure 3: Damage to magnet blocks and poles: (a) surface charring; (b) pitting.

1. Surface charring: as shown on the left side of Fig. 3, the magnet block surfaces exhibited varying degrees of charring, indicating exposure to high temperatures.
2. Pitting damage: in addition to charring, evident pits with rough surfaces were observed on some magnet blocks and poles, exhibiting typical localized ablation characteristics.

These damage characteristics clearly reveal the root cause of the magnetic field anomalies in this undulator: multiple localized, high-intensity electron or photon beam impacts occurred during long-term operation. These impacts first caused melting of the copper foil, which in turn led to thermal damage and possible microstructural destruction of the underlying magnets, resulting in an irreversible decrease in magnetization. This ultimately manifested as significant attenuation of the undulator's peak magnetic field and localized anomalies. This diagnostic outcome provides a clear basis for subsequent magnet replacement and refurbishment.

magnet replacement and re-shimming was adopted. Owing to the urgency of the repair and the limited supply of spare magnet blocks, replacement priorities were determined by the magnetic field measurement results. Magnets exhibiting severe attenuation at the upstream end or pronounced local field reductions were replaced. Slightly elevated fields were corrected by reducing the pole height. Magnets with surface charring or edge pitting that did not affect the on-axis field or the good field region were left unchanged.

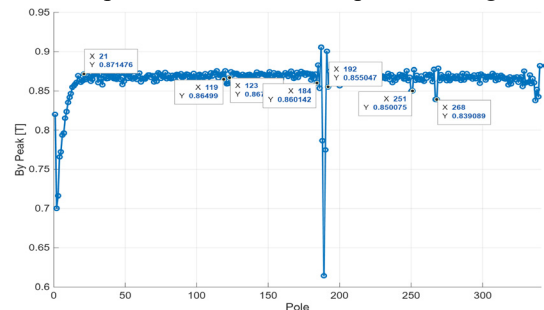
Figure 4: Peak magnetic field distribution of the damaged undulator.

As shown in Fig. 4, a sharp field reduction, with a maximum decrease of approximately 20%, was observed in the upstream region (poles No. 1–21), coinciding with the most severe surface charring shown in Fig. 3(a). The reduction gradually decreased along the beam direction. This longitudinal distribution pattern, characterized by strong reduction at the upstream and diminishes toward the downstream, indicates that beam losses distributed along the undulator are likely the primary cause of this overall reduction pattern.

As shown in Fig. 4, a slight reduction at poles No. 119–122 corresponded to the first melted hole (Fig. 2(a)). Located near the edge of the copper foil and away from the beam center, this hole had a minor impact on the on-axis field. The second hole was even farther from the beam center, at the edge of the magnet block near the mounting bracket, leaving the on-axis field at the corresponding poles No. 155–158 almost unaffected. The third hole (Fig. 2(c)) was the largest and closest to the magnet block center. This location exhibited the most severe damage, including pronounced pitting with a maximum pit size of approximately 6 mm, in addition to surface charring (Fig. 3(b)). Consequently, the on-axis field at the corresponding poles No. 187–190 was severely reduced (Fig. 4). The correlation between damage location and magnetic field anomaly provides compelling evidence that localized electron or photon beam impacts are the direct cause of these anomalous demagnetization points.

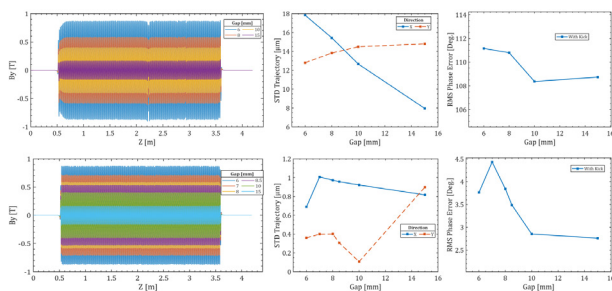
Figure 5: Comparison of magnetic field distribution, X/Y trajectory standard deviations, and phase error before and after refurbishment under multiple magnetic gaps. Upper row: before refurbishment; lower row: after refurbishment.

These results demonstrate that the undulator's magnetic field performance was successfully restored to an acceptable level. Compared with the pre-refurbishment data, the local anomalies and upstream attenuation have been effectively corrected, and the longitudinal peak field distribution has been significantly improved.

After magnet and pole replacement, re-shimming was performed to restore the phase error and electron trajectory to within design specifications. The magnetic field was then re-measured. Figure 5 compares the field distribution, X/Y trajectory standard deviations (STD), and phase error under multiple gaps before and after refurbishment (upper and lower rows, respectively). The peak-to-peak field STD was reduced from approximately 20‰ to about 4‰. The X and Y trajectory STDs dropped from maximum values of 18 and 15 to below 1.2. The phase error was reduced from over 100° to within 5° .
