HIC SUPERCONDUCTING CIRCUIT FAILURE DURING RUN 23*

Abstract

A failure of the RHIC superconducting circuit occurred at the end of Run 23 and led to an unplanned shutdown and extensive work to replace a damaged superconducting dipole magnet. After an in-depth investigation, the failure was found to originate from an electrical arc within a superconducting current lead. The arc led to large spilling of current through auxiliary superconducting circuits with limited quench stabilization, which resulted in a superconducting splice burning out. This paper will summarize our understanding of the series of events leading to the superconducting circuit damage, describe the repair work undertaken for the remaining RHIC runs and discuss some lessons learned in view of EIC operation.

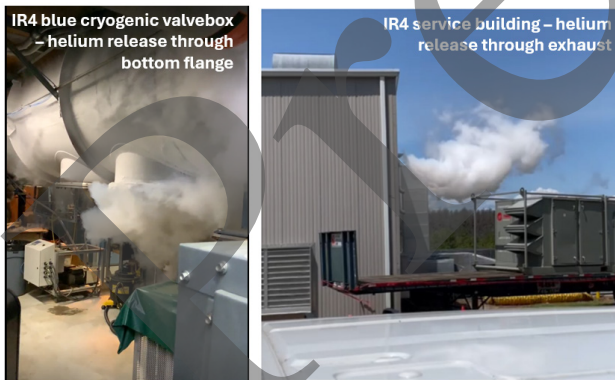
Figure 1: Aug 1st 2023 - Helium release through (left) the blue IR4 valvebox (right) the service building exhaust.

After the QLI a large helium release was witnessed at IR4 inside and outside of the service building housing the PS and the cryogenic valveboxes (Fig. 1). The release in the blue circuit valvebox bottom flange was through a volume normally under insulation-vacuum, indicating an internal rupture in the valvebox piping. Indeed, one of the 12x150 A current lead was found severely burned (Fig. 5) and a hole was burned through the stainless-steel pipe housing the current lead, indicating the location of the electrical arc. The dipole and Qv/Qh circuit short-to-ground were located at the B4DX magnet splice box connections.

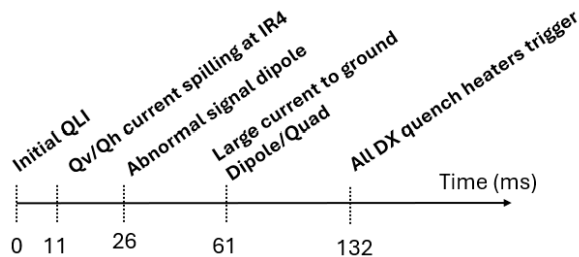
Analysis of the high-frequency signal acquisition after the QLI ($t=0$ ms), showed the first abnormal signal was a drift of the shunt circuits B4Q9 (Qh) and B4Q1(Qv) current of opposite sign ($t+11$ ms), suggesting that the two circuit were shorted together and current was spilling over between the Qv and Qh quadrupole legs (Fig. 3).

At ($t+26$ ms) abnormal signal readout also appeared on the dipole shunt circuit B4DX, part of the dipole bus.

Figure 3: Timeline of failures during the QLI event.

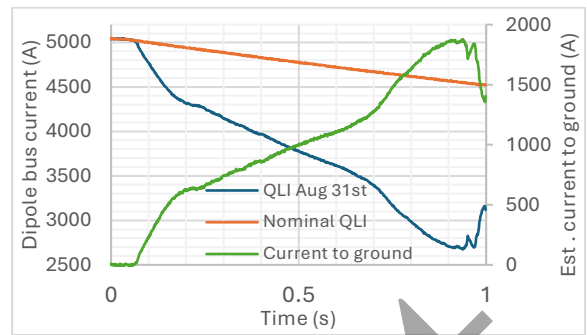
At ($t+61$ ms) after the QLI, a large ground current started to appear both on the quadrupole and dipole circuits and as a result, the magnet string current decay was much faster than usual (Fig. 4). This produced a large and sudden current variations in the SC circuit (up to 5000 A/s) which quenched many SC magnets all around the blue ring.

Figure 4: Failure - main dipole circuit current during QLI.

As discussed previously, the electrical arc in the 12x150A lead had spread to the dipole circuit through the D6 shunt circuit. This shunt circuit was designed to handle 150A only and the current-to-ground drawn through the D6 circuit was much higher. The current variation of the main dipole circuit is represented on Fig. 4 for a nominal quench (orange) and on the day of the failure (blue).

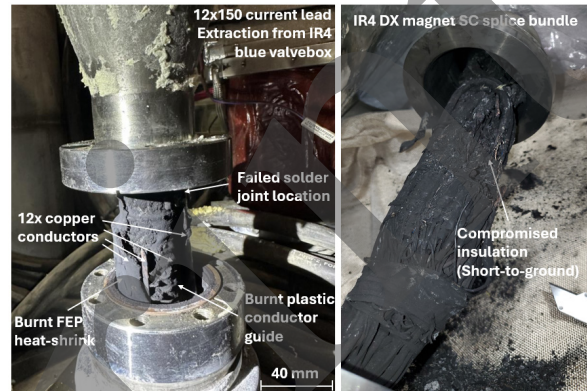
The autopsy of the 12x150A current lead showed a severely burned FEP insulation sleeve along one of the 12x vertical copper conductors (Fig. 5), the copper conductor was entirely missing on a ~ 150 mm length (Fig. 5). Upon removal, copper dust/droplets were found covering the surrounding structures.

Figure 5: Hardware damage (left) 12x150 current lead (right) DX magnet splice bundle.

The copper-copper solder joints of the 12x150A lead were examined and showed obvious defects [5, 6] such as what appears to be fatigue cracks in the solder fillet, poor solder joint geometry (blind hole) leading to limited solder penetration and voids generated by trapped soldering flux. By reviewing data from previous run, it was found that the leads were routinely undergoing significant temperature cycling at each ramp, would have compromised the lead solder joints further and eventually led to the rupture of a conductor. Fatigue testing of spare conductors has confirmed this to be a credible explanation [7].

As the QLI took place, the nominal voltage gradient (~ 100 V) developed between the Qv and Qh legs quadrupole circuit which are running through adjacent bare conductors in the 12x150A bundle. And a ruptured solder joint has led to an electrical breakdown between the Qv/Qh conductors. One of the 12x conductors also include an auxiliary shunt circuit connected to the main dipole circuit (D6 shunt). Once the lead insulation layer was compromised by the initial arc from the Qv/Qh circuit, it spread to the dipole circuit ($t+26$ ms) and eventually to ground ($t+61$ ms) before the high current-to-ground drawn through the arc burned a hole in the stainless-steel pipe housing the lead. This led to a large helium release, first in the valvebox insulation vacuum and then through the bottom flange when the Viton™ o-ring became compromised by the low temperature.

Additional damage was found in the splice connections adjacent to the DX magnet (Fig. 5). Splice connections were severely burned and short-circuited, soot has been generated that polluted the DX magnet itself and so it was later replaced it by a spare DX magnet.

The DX magnet with failed splices has been replaced by the spare DX magnet. This represented a large effort to finalize the magnet lead connections and end volume internals [11] and carry out warm magnetic testing needed to fiducialize the dipole field orientation.

The spare 12x150A current lead was also tested and installed in place of the failed lead. The root cause of the initial failure of the 12x150A lead has been investigated and described in [7]. It was found that the design improperly applies thermomechanical loads to the conductor and their solder joints. In order to mitigate the structural fatigue issue for the remaining RHIC run, a new helium-cooling algorithm has been implemented to minimize temperature cycling and extend the solder joint lifetime [7] until the end of the RHIC experimental program in 2025.

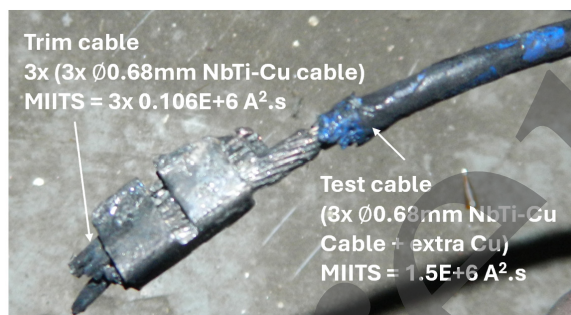
The estimated current-to-ground reached up to ~1850 A (Fig. 4) while running through the D6 shunt circuit designed for 150 A. The D6 circuit uses two types of SC cables in series, at different locations: in the so-called *cold-crossing bus* it consists of a heavily stabilized cable with a large copper content and a MIITS rating of $1.5E+6 \text{ A}^2\cdot\text{s}$ [8]. However, through the RHIC SC *magnet bus*, it uses a much less-stabilized conductor, the so-called *trim cable* consisting of 3x cables each with 3x strand of Cu-NbTi wire with a 1.75:1 Cu ratio and a MIITS rating of $0.106E+6 \text{ A}^2\cdot\text{s}$ only [2][8]. The MIITS accumulated by the current-to-ground in Fig. 4 reaches $1.3E+6 \text{ A}^2\cdot\text{s}$. So, it is unsurprising that the *trim-cable* burned in the magnet splice while the *test cable* looks undamaged (Fig. 6).

Figure 4: Failed D6 splice connection in the DX magnet.

The NbTi critical current for both these cables is high. From [9] a single $\text{Ø}0.68 \text{ mm}$ strand of a trim cable cable can sustain 270 A under 5T magnetic field. So using the SC critical surface fit from [10], at 0T and 4.2K the same strand could sustain 1350 A and so the entire trim cable (3x strands) could sustain 4050 A (at 0T) if the current is shared equally. So, the maximum ground current seen on Fig. 4 may not have sufficed to quench the entire SC cables. However, the proximity to the splice solder joint, with limited Cu stabilization and a non-ideal side-by-side conductor arrangement (Fig. 6) is likely to have generated significant resistive heat at 1850 A, enough to raise the local temperature past the cable quench limit.

As visible on Fig. 6 the SC splice had a limited Cu stabilization and a cable arrangement not conducive to good current-sharing between cables (*trim cables* are arranged side-by-side when they should ideally be around the *test cable* to favor current-sharing and limit the splice resistance). A review of the SC splice design should aim to minimize splice resistance and maximize quench stabilization. Especially in areas that are hard to access and can foreseeably impose a long shutdown for future damage repair. Instead, easier to access areas could be purposefully equipped with lower-stabilization splices, acting as fuses, and potentially be equipped with local electrical diagnostic probes to simplify the fault location and the SC system recovery effort in the future.
