# ANALYSIS AND REFURBISHMENT OF A RADIATION-DAMAGED UNDULATOR\*

Shanghai Advanced Research Institute, Chinese Academy of Sciences, Shanghai, China

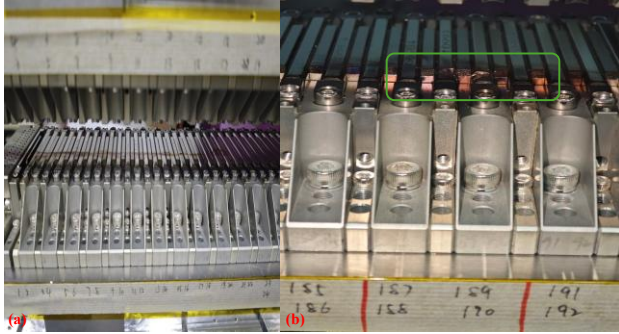
To further assess the actual damage to the magnets, the copper foil was removed, and the exposed surfaces of the magnet blocks and poles were examined in detail. As shown in Fig. 3, distinct types of damage were observed on these surfaces, primarily including:

1. Surface charring: as shown on the left side of Fig. 3, the magnet block surfaces exhibited varying degrees of charring, indicating exposure to high temperatures.
2. Pitting damage: in addition to charring, evident pits with rough surfaces were observed on some magnet blocks and poles, exhibiting typical localized ablation characteristics.

Figure 3: Damage to magnet blocks and poles: (a) surface charring; (b) pitting.

These damage characteristics clearly reveal the root cause of the magnetic field anomalies in this undulator: multiple localized, high-intensity electron or photon beam impacts occurred during long-term operation. These impacts first caused melting of the copper foil, which in turn led to thermal damage and possible microstructural destruction of the underlying magnets, resulting in an irreversible decrease in magnetization. This ultimately manifested as significant attenuation of the undulator's peak magnetic field and localized anomalies. This diagnostic outcome provides a clear basis for subsequent magnet replacement and refurbishment.

magnet replacement and re-shimming was adopted. Owing to the urgency of the repair and the limited supply of spare magnet blocks, replacement priorities were determined by the magnetic field measurement results. Magnets exhibiting severe attenuation at the upstream end or pronounced local field reductions were replaced. Slightly elevated fields were corrected by reducing the pole height. Magnets with surface charring or edge pitting that did not affect the on-axis field or the good field region were left unchanged.

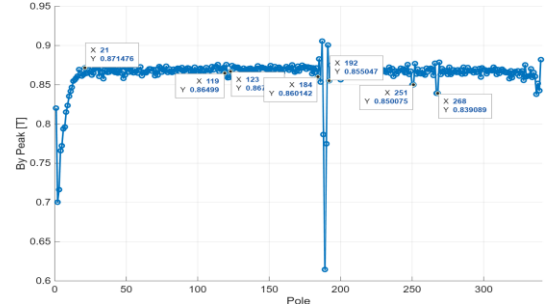
Figure 4: Peak magnetic field distribution of the damaged undulator.

As shown in Fig. 4, a sharp field reduction, with a maximum decrease of approximately 20%, was observed in the upstream region (poles No. 1–21), coinciding with the most severe surface charring shown in Fig. 3(a). The reduction gradually decreased along the beam direction. This longitudinal distribution pattern, characterized by strong reduction at the upstream and diminishes toward the downstream, indicates that beam losses distributed along the undulator are likely the primary cause of this overall reduction pattern.

As shown in Fig. 4, a slight reduction at poles No. 119–122 corresponded to the first melted hole (Fig. 2(a)). Located near the edge of the copper foil and away from the beam center, this hole had a minor impact on the on-axis field. The second hole was even farther from the beam center, at the edge of the magnet block near the mounting bracket, leaving the on-axis field at the corresponding poles No. 155–158 almost unaffected. The third hole (Fig. 2(c)) was the largest and closest to the magnet block center. This location exhibited the most severe damage, including pronounced pitting with a maximum pit size of approximately 6 mm, in addition to surface charring (Fig. 3(b)). Consequently, the on-axis field at the corresponding poles No. 187–190 was severely reduced (Fig. 4). The correlation between damage location and magnetic field anomaly provides compelling evidence that localized electron or photon beam impacts are the direct cause of these anomalous demagnetization points.

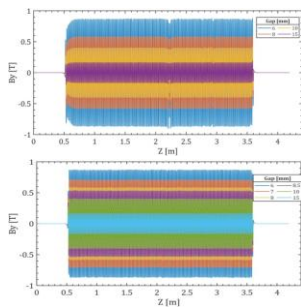
These results demonstrate that the undulator's magnetic field performance was successfully restored to an acceptable level. Compared with the pre-refurbishment data, the local anomalies and upstream attenuation have been effectively corrected, and the longitudinal peak field distribution has been significantly improved.

Figure 5: Comparison of magnetic field distribution. Upper row: before refurbishment; lower row: after refurbishment.

After magnet and pole replacement, re-shimming was performed to restore the phase error and electron trajectory to within design specifications. The magnetic field was then re-measured. Figure 5 and 6 compares the field distribution, X/Y trajectory standard deviations (STD), and phase error under multiple gaps before and after refurbishment (upper and lower rows, respectively). The peak-to-peak field STD was reduced from approximately 20‰ to about 4‰. The X and Y trajectory STDs dropped from maximum values of 18 and 15 to below 1.2. The phase error was reduced from over  $100^\circ$  to within  $5^\circ$ .

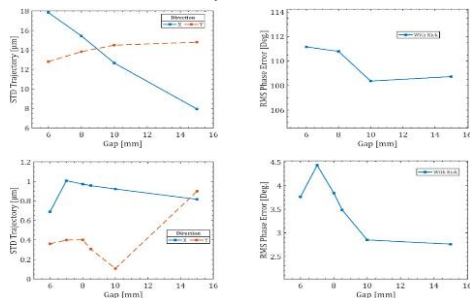
Figure 6: Comparison of X/Y trajectory standard deviations, and phase error before and after refurbishment under multiple magnetic gaps. Upper row: before refurbishment; lower row: after refurbishment.
