REPAIR AND IMPROVEMENT OF THE SUPERCONDUCTING MAGNETS OF THE S³ SPECTROMETER AT GANIL

In order to achieve optimal performance in terms of transmission and separation for the S³ spectrometer, the project chose to design superconducting magnets integrating 11 magnetic functions in a single cryostat. There are seven of these magnets, called Superconducting Multipole Triplets, in the spectrometer. The compactness of these magnets makes them remarkable and unique, but has led to significant commissioning difficulties. As the design was very close to the acceptable operating limits, we experienced several breakages and leaks, as well as limitations in terms of nominal current. In this presentation, we will show the important work we carried out to repair the main conductor, improve the robustness of the current leads and feedthrough, and repair the various leaks.

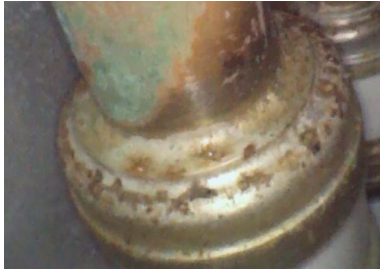
Figure 7: Oxidation.

side, even in cryogenic and vacuum environment. When the first leaks appeared coming from the liquid nitrogen reservoir, we run overhaul checks and found out many oxidized feedthrough (Fig. 7).

We identify solder flux pollutions as precursor coupled with water/oxygen on cold surfaces to be the cause of this corrosion. We have to change four SMT set of feedthrough (16 each) by performing openings from the top side and removal of HTS on the bottom end. It allowed us to design our own coupling parts from the raw on-shelf products (Fig. 8).

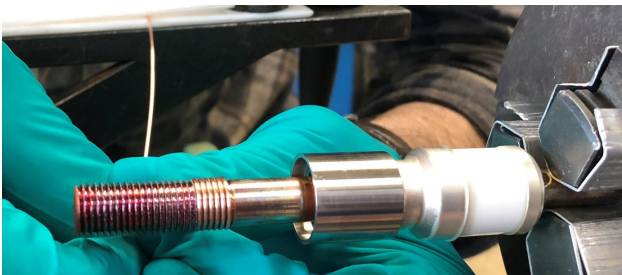
Figure 9: LTS wiring on specific machined feedthrough.

Instead of soft solder and screw mechanism, we now use indium sheet, bolts and protection measures such as dry nitrogen filling to insure the longevity of the overall system. The one made to repair the LTS wire from the Helium tank had to more specific (Fig. 9). We made it longer, shaped it to receive the wire and fit the cramped area. Each one of the HTS replacement in their upper side has to be done with In52/Sn48 (118°C) and great cooling to prevent melting of the lower section done with Sn60/Pb40 solder (183°C).

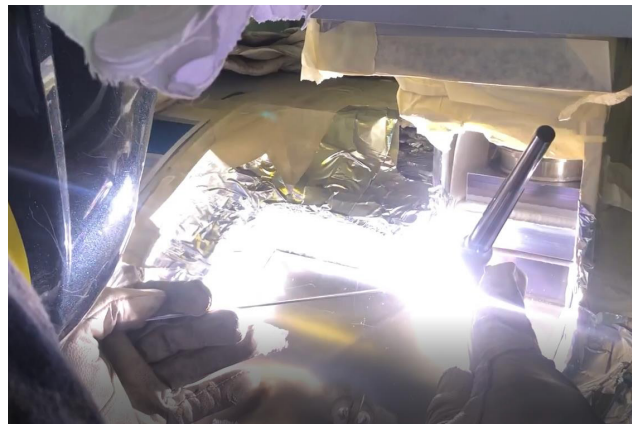
Figure 10: Aluminium tank TIG welding.

Each openings in the cryostat, had to be carefully planned and executed in order to be able to close it after. The top 19 mm stainless steel plate was fully machined to receive a 7 mm elastomer joint for atmospheric isolation. Two openings per Nitrogen tank were performed in the aluminium enclosure. The process of sealing this pressurized, cryogenically cooled box in vacuum drove several iteration and test. First a 5mm Indium wire, then two 1mm Indium threads on a frame, and now a custom made aluminium knife edge joint. We use ventilated screw to prevent virtual leaks and specific Belleville washers to keep plates firmly held onto the Nitrogen enclosure. The most difficult part is the 6mm aluminium TIG welding of the liquid Helium tank closure (Fig. 10). To achieve perfect sealing on a large cylinder cooled at 4 K in vacuum is no small feat. While protecting electrical connection 10mm away and not burning the Multi-Layer Insulation tightly set around the cryostat. Extensive preparation, tests and ultrasonic quality control is being carried out by our welding team to achieve this goal.
