LINAC 2026 | DAEJEON, SOUTH KOREA

# Post-Mortem Insights into the SNS RFQ01: Implications and Paths Forward for High Beam Power Operation

Haitao Ren

Spallation Neutron Source, ORNL

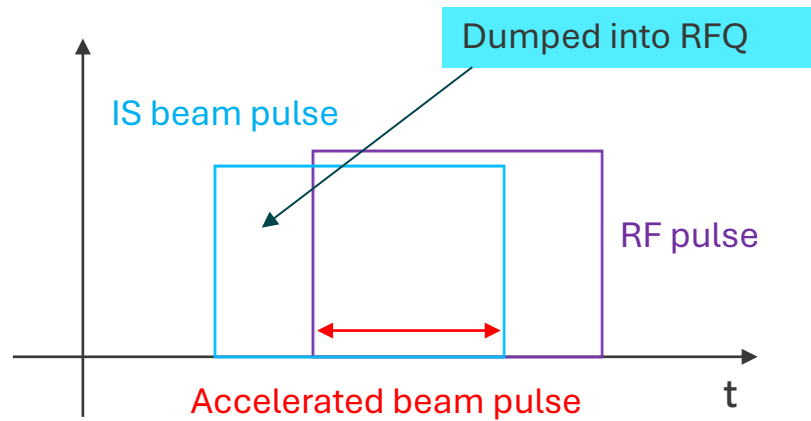
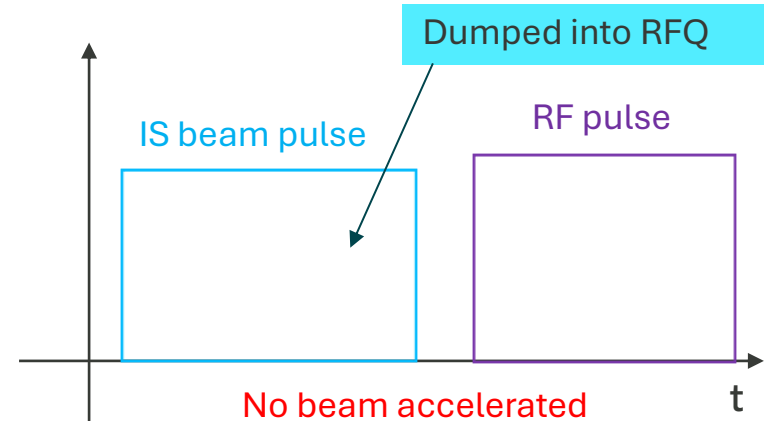
SNS Beam Mode

SNS Beam-off Mode

- SNS ion source (IS) produces 1000  $\mu$ s beam pulses at 60 Hz
- IS pulse to be synchronized with RFQ RF pulse
- Accelerated beam pulse is the overlap between IS pulse and RF pulse
- Beam-off mode (during troubleshooting, or short maintenance) dumps all unsynchronized pulses to the RFQ entrance

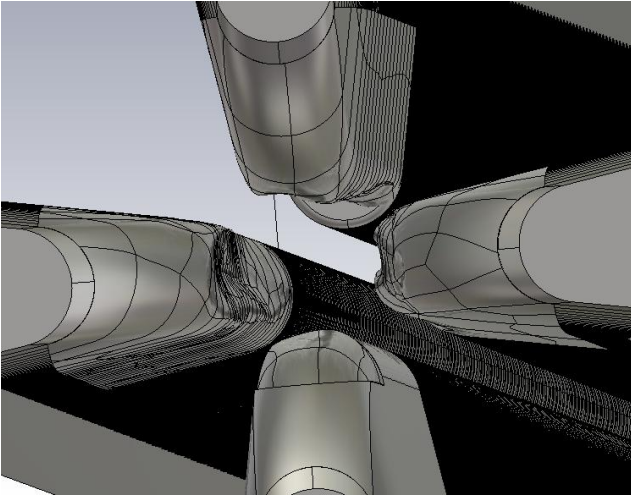
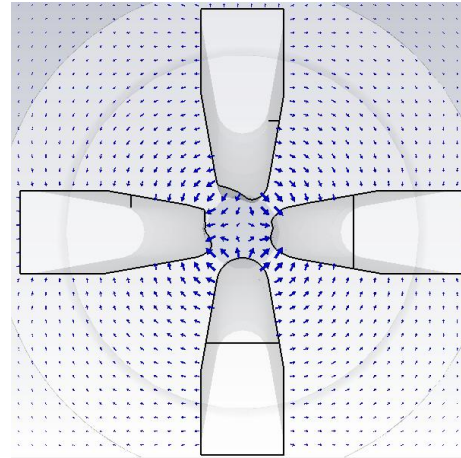
E-field distribution at Z=8 cm

- The laser-scanned erosion model was applied to the RFQ 3D model
- Vane field distribution was re-calculated
- Both longitudinal and transverse field patterns have been compromised at erosion area

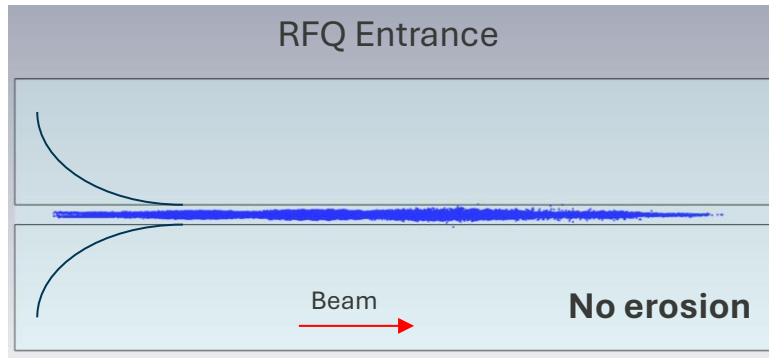
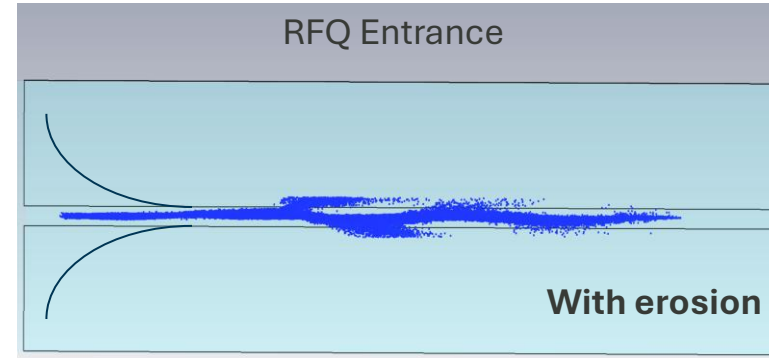
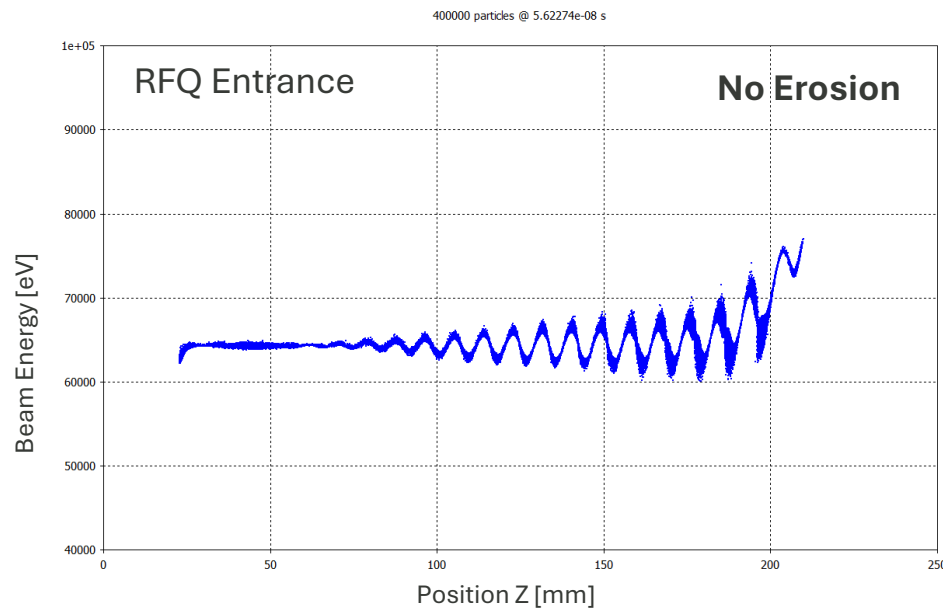
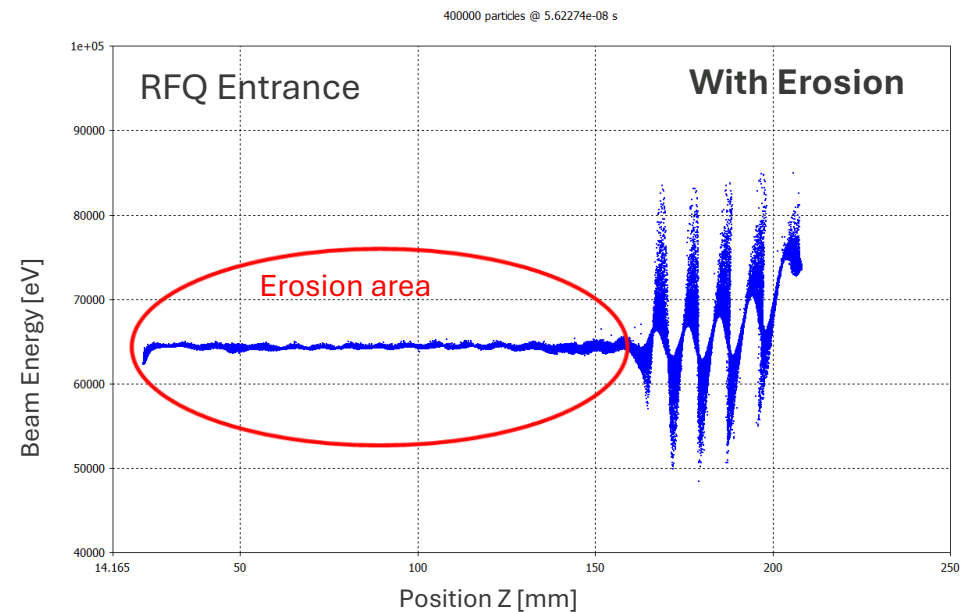
Particle view at RFQ entrance

Beam Energy vs. Z (0 – 200mm)

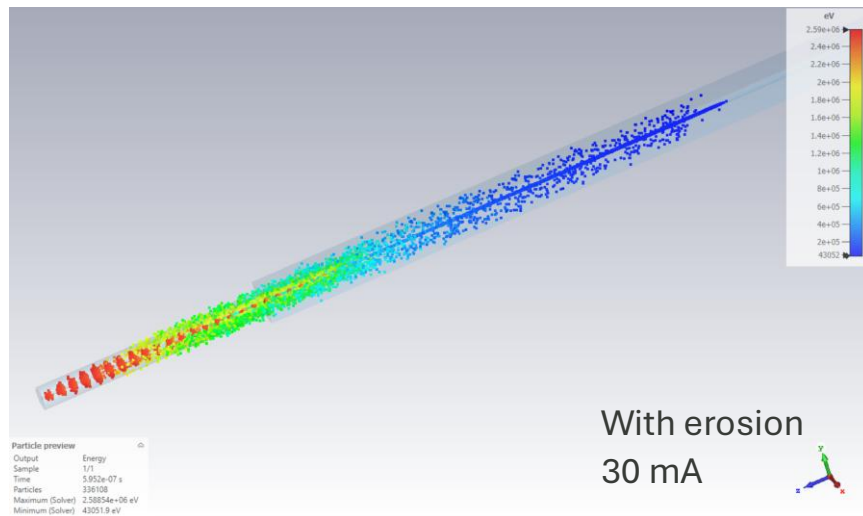
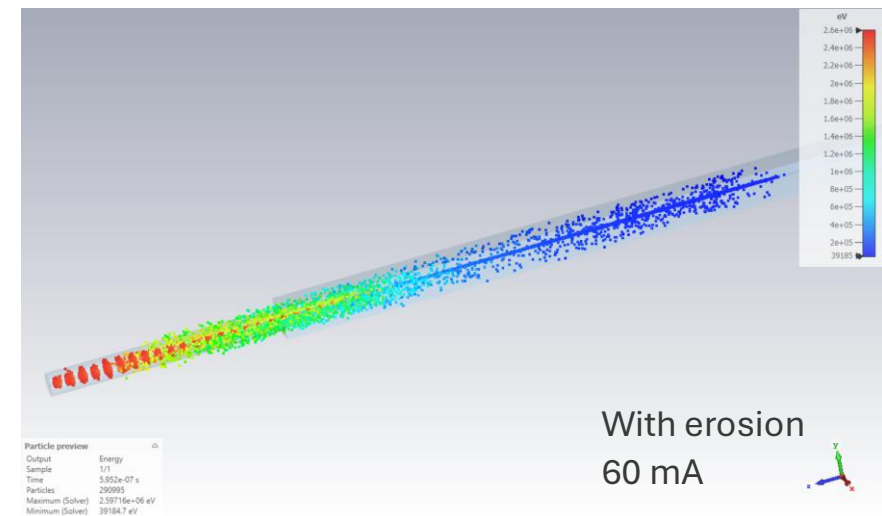
With Erosion

Considering the entrance erosion only, RFQ beam transmission drops by about 20%

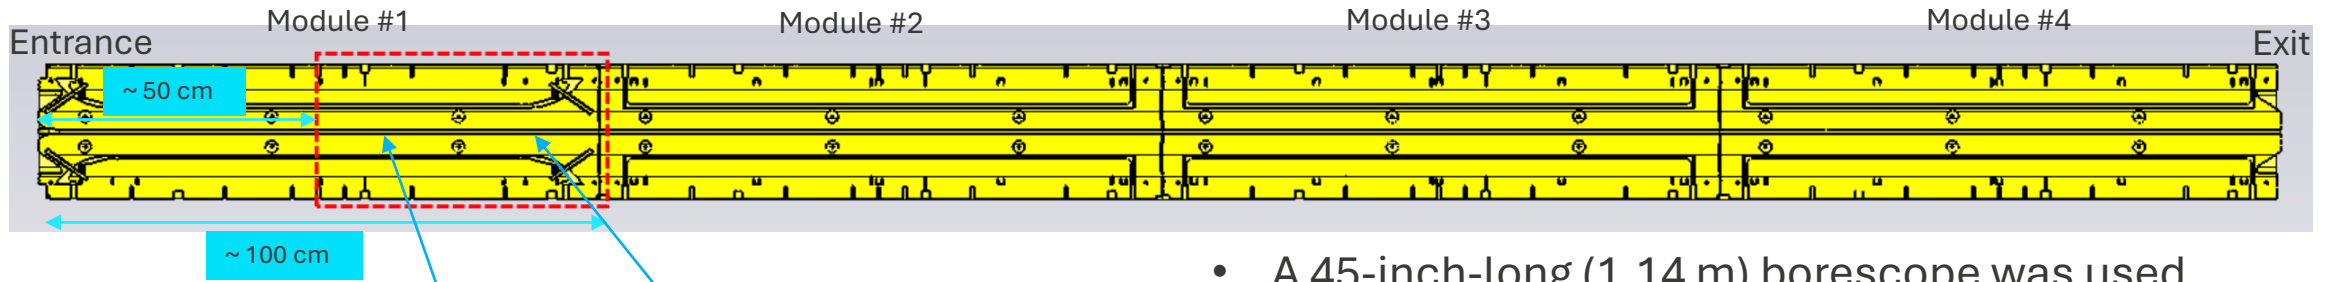
- A 45-inch-long (1.14 m) borescope was used
- Not long enough to cover the full cavity

More erosion damage observed on vane tips in the second half of Module #1

- Entrance erosion correlates with the 65 keV input beam
- Localized erosion in downstream section of Module 1 needs better understanding
- Routine borescope inspection now applied to other SNS RFQs
- Mitigations at SNS:
  - Chopper upgraded to blank RFQ beam off-cycle – implemented
    - IS beam fully chopped now, won't enter RFQ
  - Under study:
    - Magnetic LEBT option
    - Additional collimation before RFQ
    - New RFQ design study for higher transmission

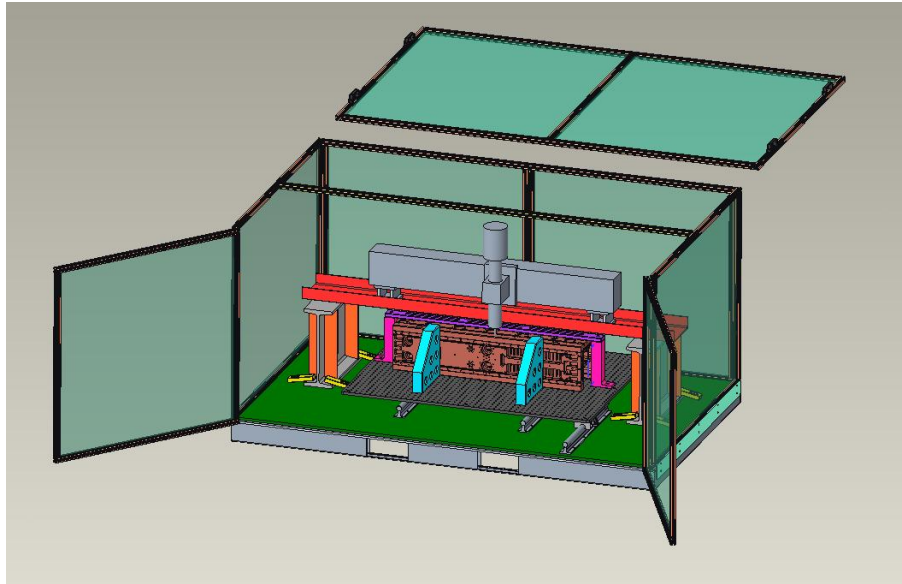
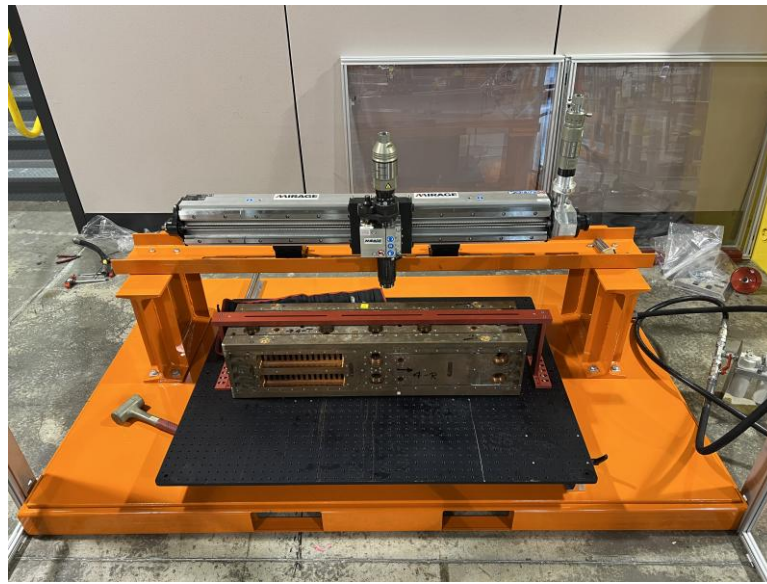
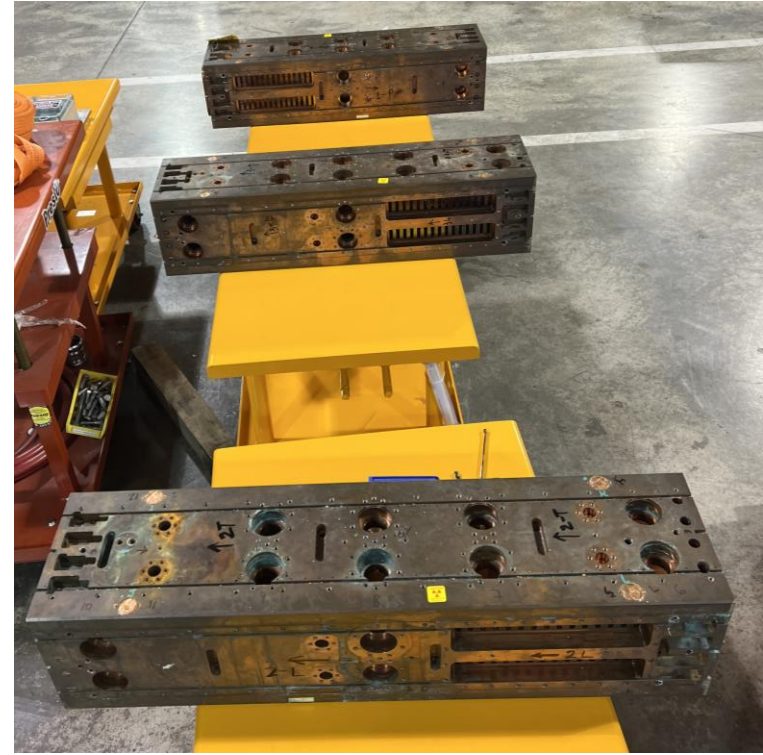
- RFQ01 is planned to be cut for a full-length scan
- Cutting fixture has been fabricated and is currently under assembly testing
