CURRENT STATUS OF TPS VACUUM SYSTEM

Yi-Ch. Yang[†], Ch.-K. Chan, Ch.-Ch. Chang, Bo-Y. Chen, Ch.-Mu Cheng, T.-W. Hsu, J.-H. Kang,
National Synchrotron Radiation Research Center, Hsinchu, Taiwan

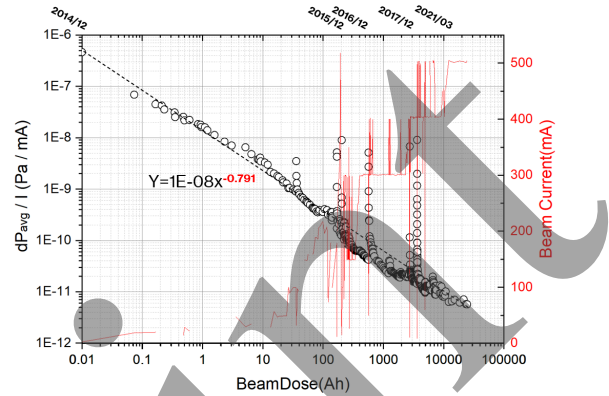
The vacuum pressure distribution of the storage ring under 500mA operation is illustrate in Fig. 1, which shows a higher pressure spike in the SR24 section resulting from the machine upgrade in 2026. The dynamic average pressure is 8.9 nPa, compared to a static pressure of 6.8 nPa without beam. To date, 17 insertion devices (IDs), two superconductivity cavities, and one harmonic cavity (HC) have been installed in the straight sections of the storage ring. Corresponding vacuum components, including bending magnet chambers and front-end (FE) vacuum system, have also been upgraded [1, 2]. The lumped NEG-ion combination pumps used in EPU ID vacuum chamber was developed to improve and increase the effective pumping speed [3]. A vacuum gauge was installed at the center of each EPU chamber to measure local pressure accurately. The average pressure rise normalized to the beam current dP/I (Pa / mA), follows a downward trend proportional to $D^{-0.791}$, was shown as Fig. 2.

Figure 2: The average pressure rise normalized to the beam current.
