HIC SUPERCONDUCTING CIRCUIT FAILURE DURING RUN 23*

Abstract

A failure of the RHIC superconducting circuit occurred at the end of Run 23 and led to an unplanned shutdown and extensive work to replace a damaged superconducting dipole magnet. After an in-depth investigation, the failure was found to originate from an electrical arc within a superconducting current lead. The arc led to large spilling of current through auxiliary superconducting circuits with limited quench stabilization, which resulted in a superconducting splice burning out. This paper will summarize our understanding of the series of events leading to the superconducting circuit damage, describe the repair work undertaken for the remaining RHIC runs and discuss some lessons learned in view of EIC operation.

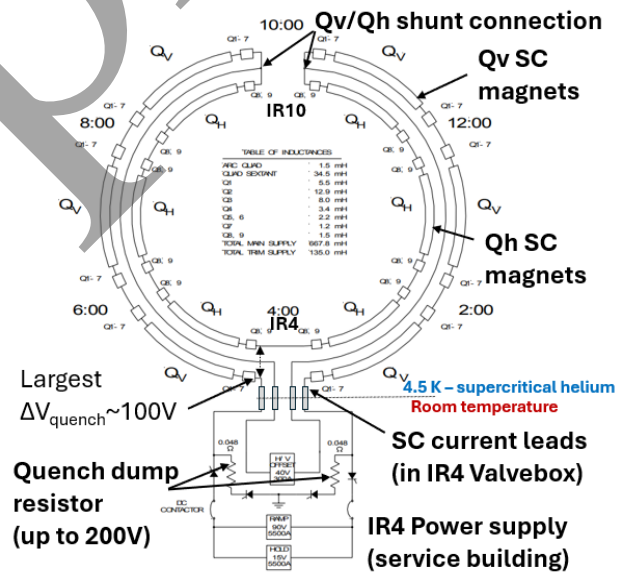
Figure 2: Sketch of the RHIC quadrupole SC circuit [2].

During a quench, the quadrupole circuit voltage goes up to ~200V at the dump resistor, driven by the inductance of the large number of SC magnet wired in series during the current decay.

Any two points of the circuit will see a different voltage-to-ground depending on how many SC magnets separate them. The highest wire-to-wire voltage difference will reach ~100V (~50% of the total dump resistor voltage) at IR4 between the Qh/Qv legs. (see Fig. 2).
