POST-PROCESSING OF ADDITIVELY MANUFACTURED PURE COPPER RFQ ELEMENTS*

T. Romano[†], M. Vedani, Politecnico di Milano, Milan, Italy

Abstract

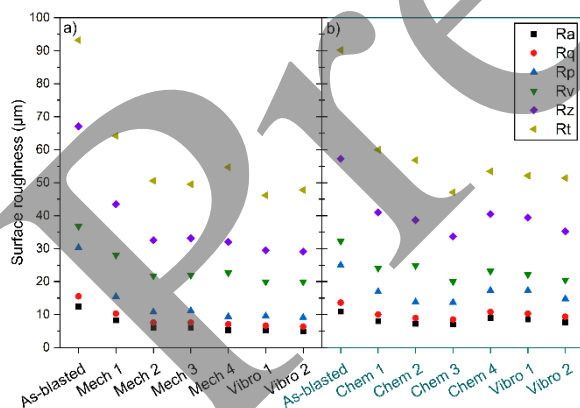
Figure 4: Surface roughness of samples subjected to mechanical (a) and chemical treatments (b).

The surface roughness parameters of the investigated samples in the various conditions are shown in Fig. 4. For the mechanically treated part, roughness parameters show a clear decreasing trend up to the second cycle (Fig. 4a). A similar behavior is observed for the peak-related parameters (R_p , R_z , R_t), indicating an effective removal of the highest asperities. The last two cycles led to moderate decrease in roughness, suggesting that the process approaches a plateau. Overall, R_a decreased from $12.5\ \mu\text{m}$ to $5.3\ \mu\text{m}$ after four mechanical cycles. A similar trend is observed for R_q ; however, the R_q/R_a ratio slightly increased from ~ 1.25 to ~ 1.35 during the treatment, which may be attributed to the remaining deeper valleys that were not effectively removed by the process, as also suggested by the limited decrease in R_v . Vibrofinishing had an additional smoothing effect, resulting in a final R_a of $\sim 4.9\ \mu\text{m}$.

The chemical treatment led to a decrease in roughness parameters up to cycle 3 (R_a decreases from ~ 11 to $\sim 7\ \mu\text{m}$), followed by an increase during cycle 4 (R_a of ~ 8.9) due to part oxidation caused by prolonged immersion in the chemical solution, localized surface effects associated with the chemical process, and reduced smoothing efficiency due to partial exhaustion of the chemical agents. Roughness slightly decreased after vibrofinishing, resulting in a final R_a of $\sim 7.7\ \mu\text{m}$, possibly due to partial removal of surface oxides, which were only observed in localized regions during SEM analyses.
